# The Architecture of the Red Monastery Church (Dayr Anbā Bišūy) in Egypt *An Evolving Anatomy*

NICHOLAS WARNER

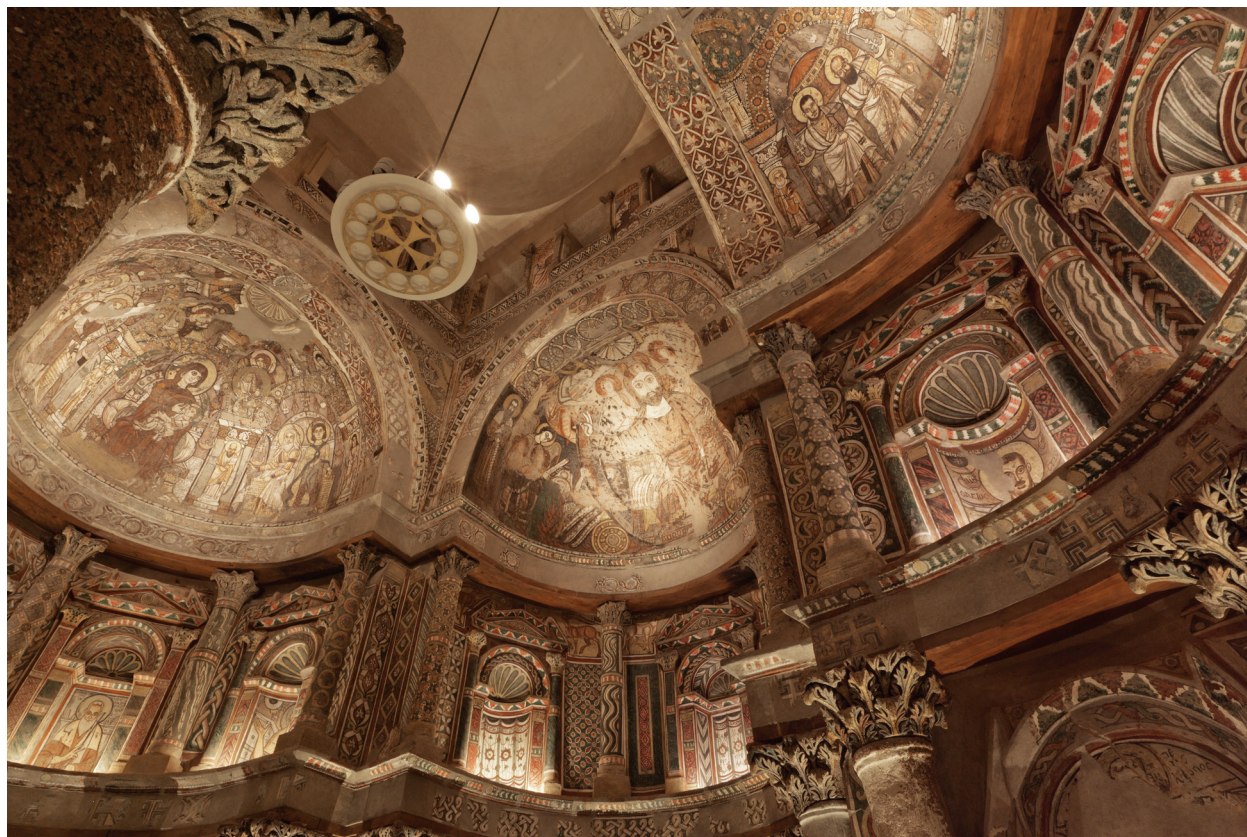
FIG. 1. The interior of the late antique sanctuary of the Red Monastery church after conservation, 2014 (photo: Pedro Gomez)

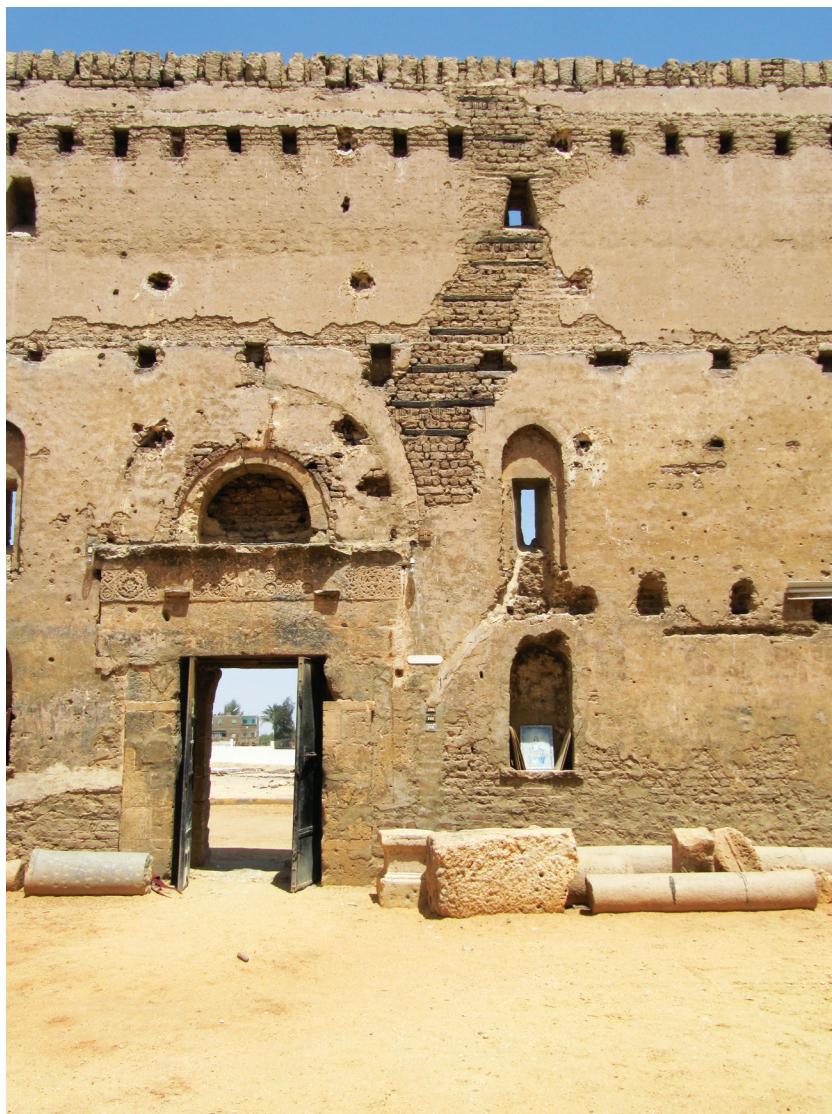
FIG. 2.  
The inner north wall  
of the Red Monastery  
church, 2011, showing the  
north portal, beam holes  
for the destroyed timber  
superstructure of the  
nave, and modern repairs  
(photo: author)

whose pockmarked walls bear witness to profound historical change (fig. 2). Extensive restorations have further modified many parts of the building, thus creating a complex stratigraphy that requires detailed analysis before any conclusions can be reached. This article attempts to provide such an interpretative study.

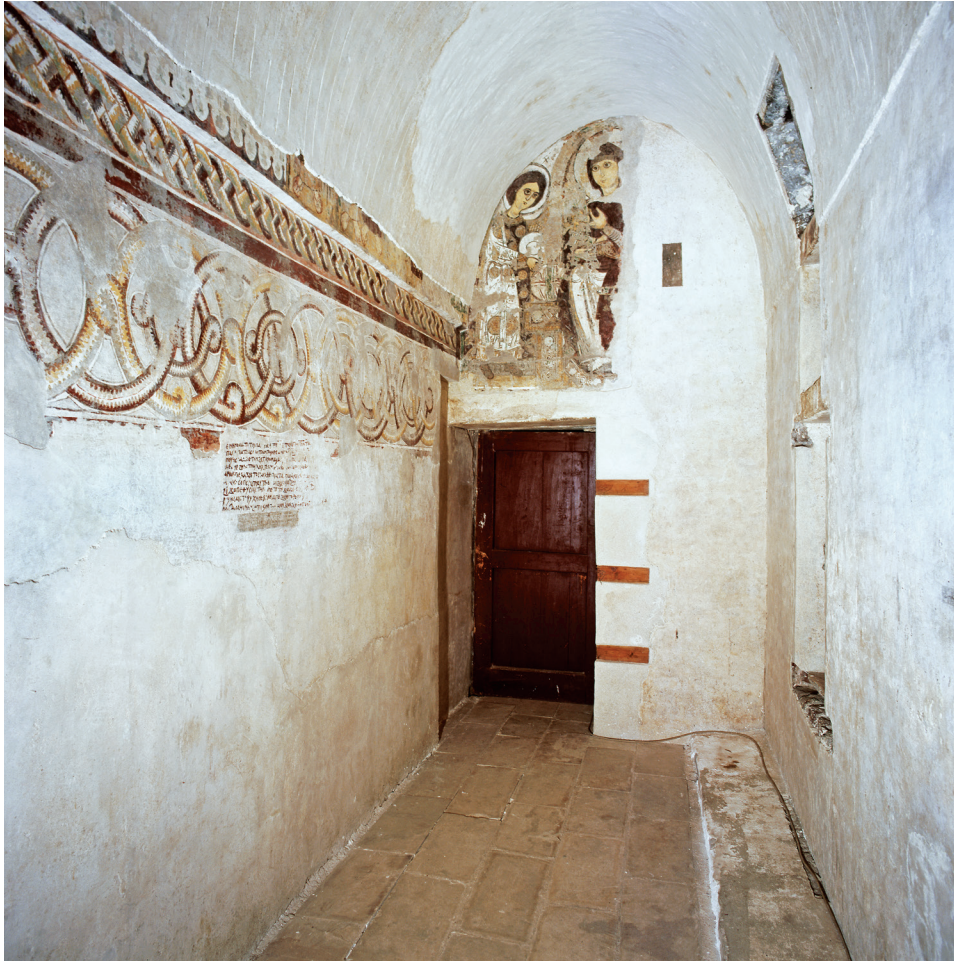
FIG. 4.

View of north long side chamber looking west, 2012, showing late antique paintings on south wall, medieval paintings on west wall, reconstructed elliptical vault, and break in the end wall between first- and second-phase construction (photo: A. Vescovo, courtesy of the American Research Center in Egypt)

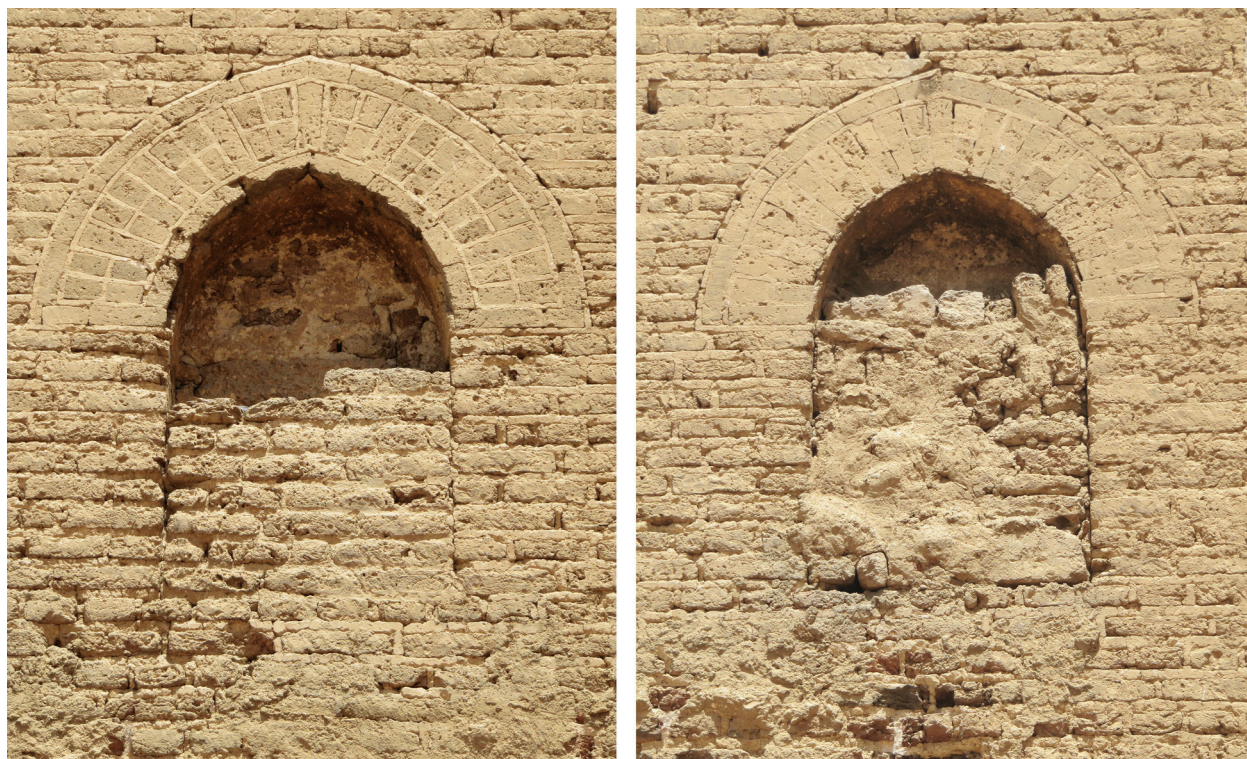
FIG. 5. Two pointed arches from the lower tier of windows of the south facade, 2011, showing variations in hood design (photos: author)

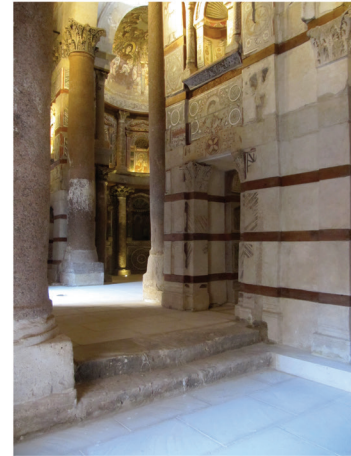
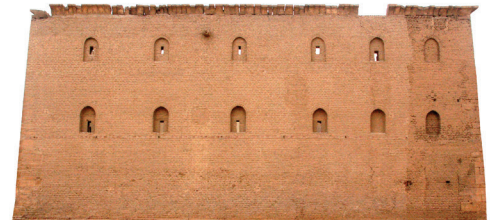
FIG. 6.

**1** Reconstructed plan of late antique church showing hypothetical west door with, to right, view of bema and sanctuary facade;  
**2** Plan of rebuilt walls and new tower with, to right, the west elevation showing use of pointed arches (photo: author);  
**3** Plan of reduced area of church, new Church of the Virgin, and interior village houses (in gray tone) with, to right, the wall enclosing the east end of the church, 1897–98 (photo: Wladimir de Bock, from *Matériaux* [n. 22 above], pl. 25);  
**4** Plan of existing condition with, to right, the modern wall and roof structure in front of the sanctuary facade and nave columns (photo: author)

Previous reconstructions do not make a sharp distinction between the original foundation of the late antique church and its medieval rebuild (fig. 6, plans 1 and 2). This is perhaps understandable because the rebuilt church seems to have followed the design of its predecessor very closely in order to utilize preexisting foundations and the positions of the north and south portals. A continuity of construction must also have applied to the structure of the nave and its roof. The rebuilding may, however, have omitted certain features original to the first foundation. It obviously employed a more contemporary architectural language, with pointed rather than semicircular arches. In general, however, the rebuilding appears to have been meant to be faithful to the original—even to the extent of replacing the limestone cavetto cornice atop the enclosure walls (discussed further below). Thus, any proposed reconstruction of the late antique church must rely heavily on

Further deterioration and collapse seem to have followed the first rebuilding of the Red Monastery church, for which, once again, no precise chronological data exists. It is known, however, that when the church was restored for the second time, the nave was abandoned and a new wall, made of fired brick set in mud mortar with some limestone coursing, was built on a north–south alignment four meters to the west of the sanctuary facade, effectively shrinking the church (fig. 6, plan 3). The eighteenth-century English prelate Richard Pococke (1704–65) provides a terminus ante quem for this development as he observed that the wall was in place when he visited the church in 1737.<sup>26</sup> The space thus created was roofed with a variety of brick vaults, constructed below the top of the sanctuary facade that can be seen protruding above them in nineteenth- and early twentieth-century photographs (fig. 6, to right of plan 3). A replacement dome was

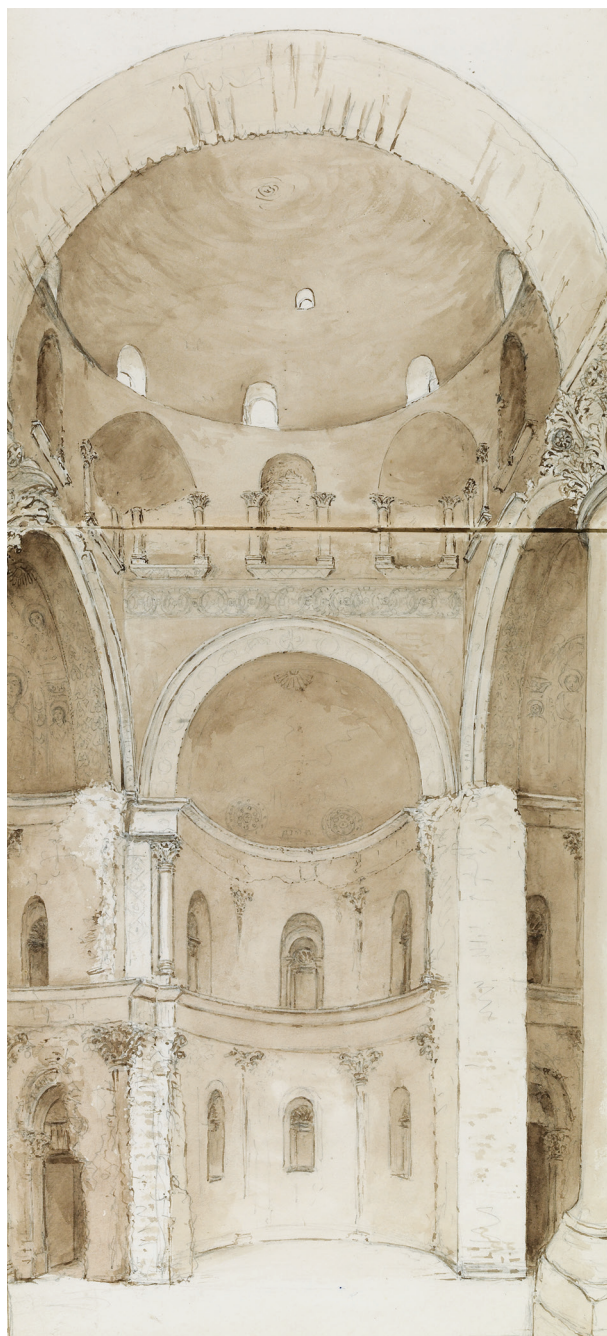
FIG. 8.  
Interior of the sanctuary of the Red Monastery church ca. 1856 (watercolor: John Gardner Wilkinson, University of Oxford, Bodleian Library, Ms. Wilkinson dep.d.34, fol. 18, courtesy National Trust Images)

probably built over the sanctuary at the same time. It is also likely that during this phase of activity blocking walls were built within the three conches of the sanctuary to prevent the collapse of their entablatures, a critical intervention that preserved both the structure and the decoration of the sanctuary. A watercolor by Wilkinson dating to the 1850s is the earliest record of these walls (fig. 8).

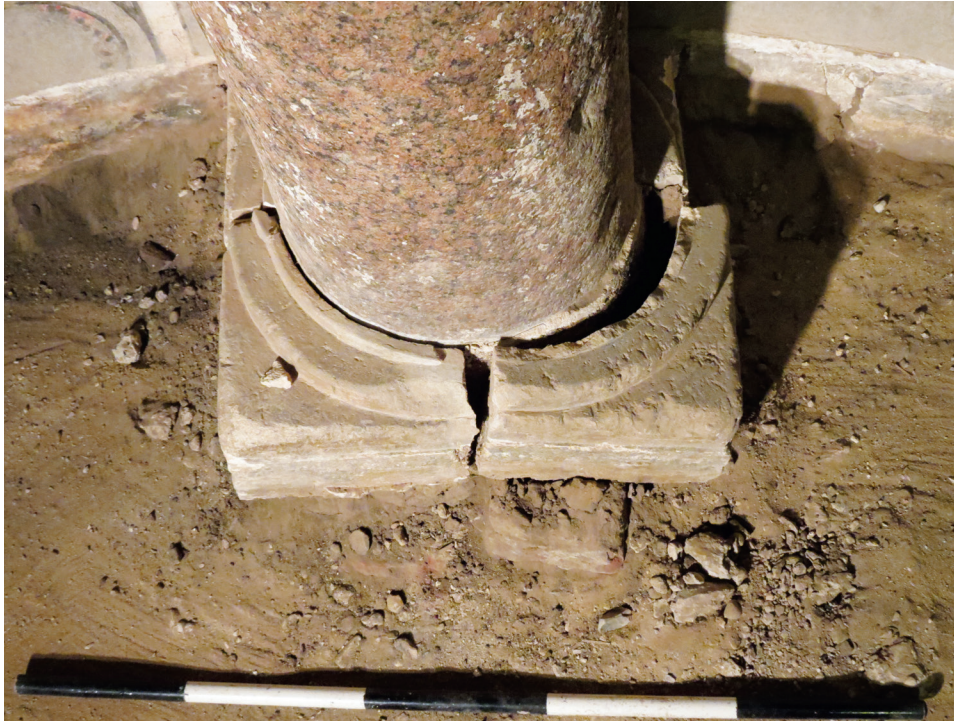
FIG. 10.  
View of limestone  
collar around central  
granite column shaft  
in south conch of  
sanctuary prior to  
conservation, 2013  
(photo: Gillian Pyke)

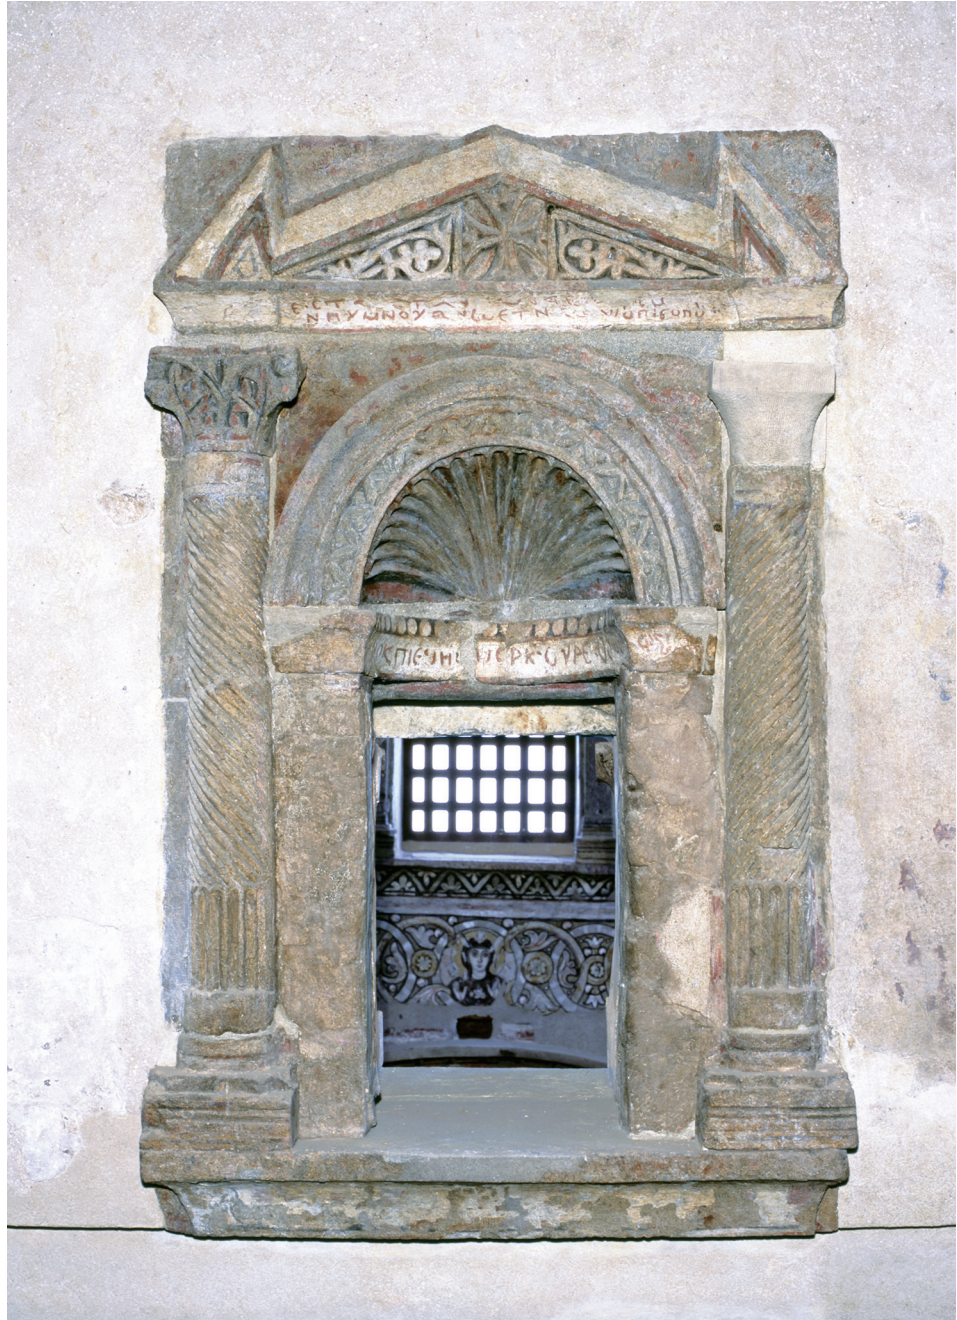
FIG. 19.  
Carved limestone niche  
above central arch in  
sanctuary facade, 2012  
(photo: A. Vescovo,  
courtesy of the American  
Research Center in Egypt)

Another major issue for the reconstruction of the sanctuary facade is the link between the clerestory of the sanctuary and the nave. At present, a single original and highly elaborate niche with a small aperture connects the two spaces (fig. 19). Two small rectangular openings, created during the 1909 restoration, flank this niche.<sup>84</sup> These two openings relate to small

niches on the interior of the sanctuary clerestory but have no external articulation at present. Did they ever exist, and if so were they framed architecturally in a manner similar to the central niche? Although these questions cannot be resolved, the central opening on the sanctuary facade indicates, by its height relative to the clerestory windows of the sanctuary, a primary architectural relationship between this niche and the nave of the church. The fact that the niche on the nave side of the sanctuary crossing is lower and smaller than those on the other elevations of the clerestory is difficult to comprehend except as a result of this relationship. The reconstruction of the facade shows the niches flanking the central niche in dashed lines to indicate their uncertain status (fig. 17).

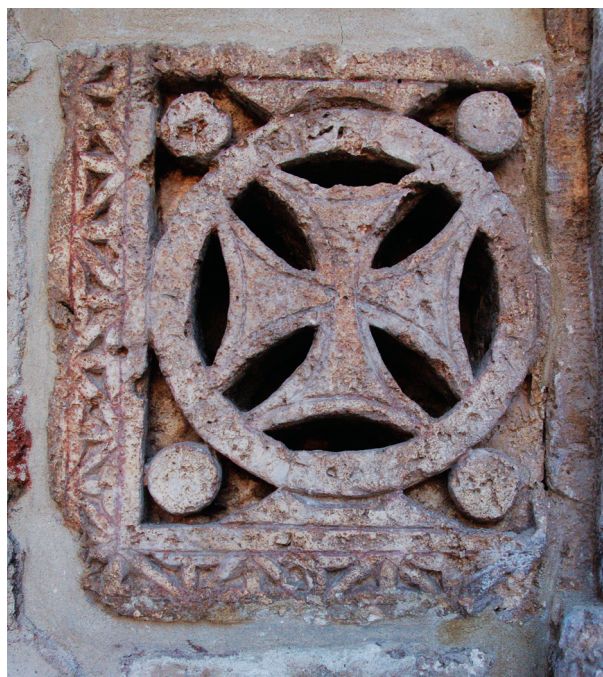
FIG. 20. One of the carved openwork blocks among the spolia within the trilobe portal (photo: author, 2014)

century onward.<sup>64</sup> There is also limited evidence for the possible use of stone window grilles in the church at some point in its history. Two spoliated decorative limestone blocks, reused in an assemblage within the later trilobe portal, have crosses within them that are carved through the full thickness of the block (fig. 20). Carved borders on two sides indicate that they were once part of larger grille assemblies. It is equally possible, however, that such blocks formed a section of a semitransparent screen or perforated balustrade and not a window.

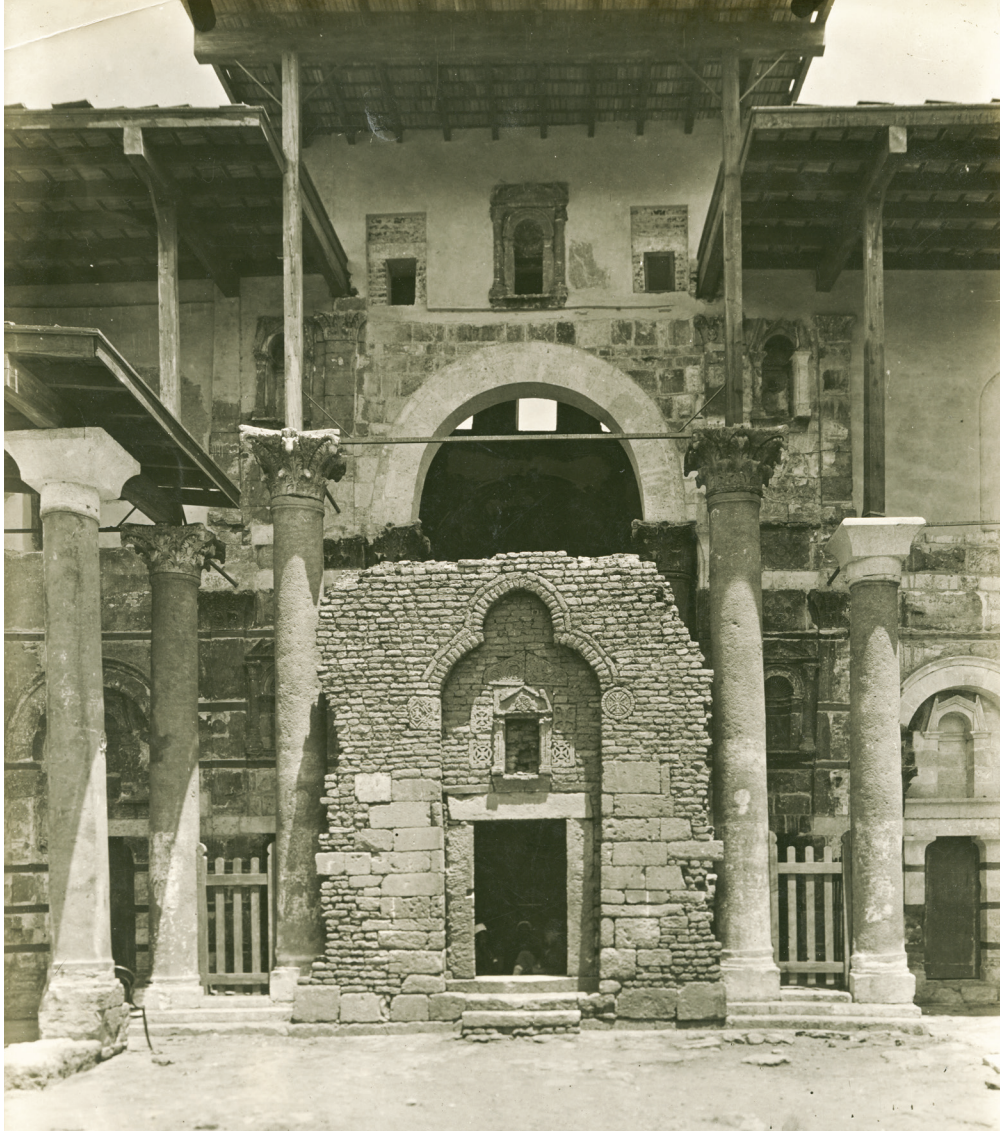
FIG. 22.  
View of the east end of the Red Monastery church during the Comité's restoration of 1909–12 showing the relationship of columns to the sanctuary facade (unknown photographer; Istituto Nazionale di Archeologia e Storia dell'Arte, 66806)

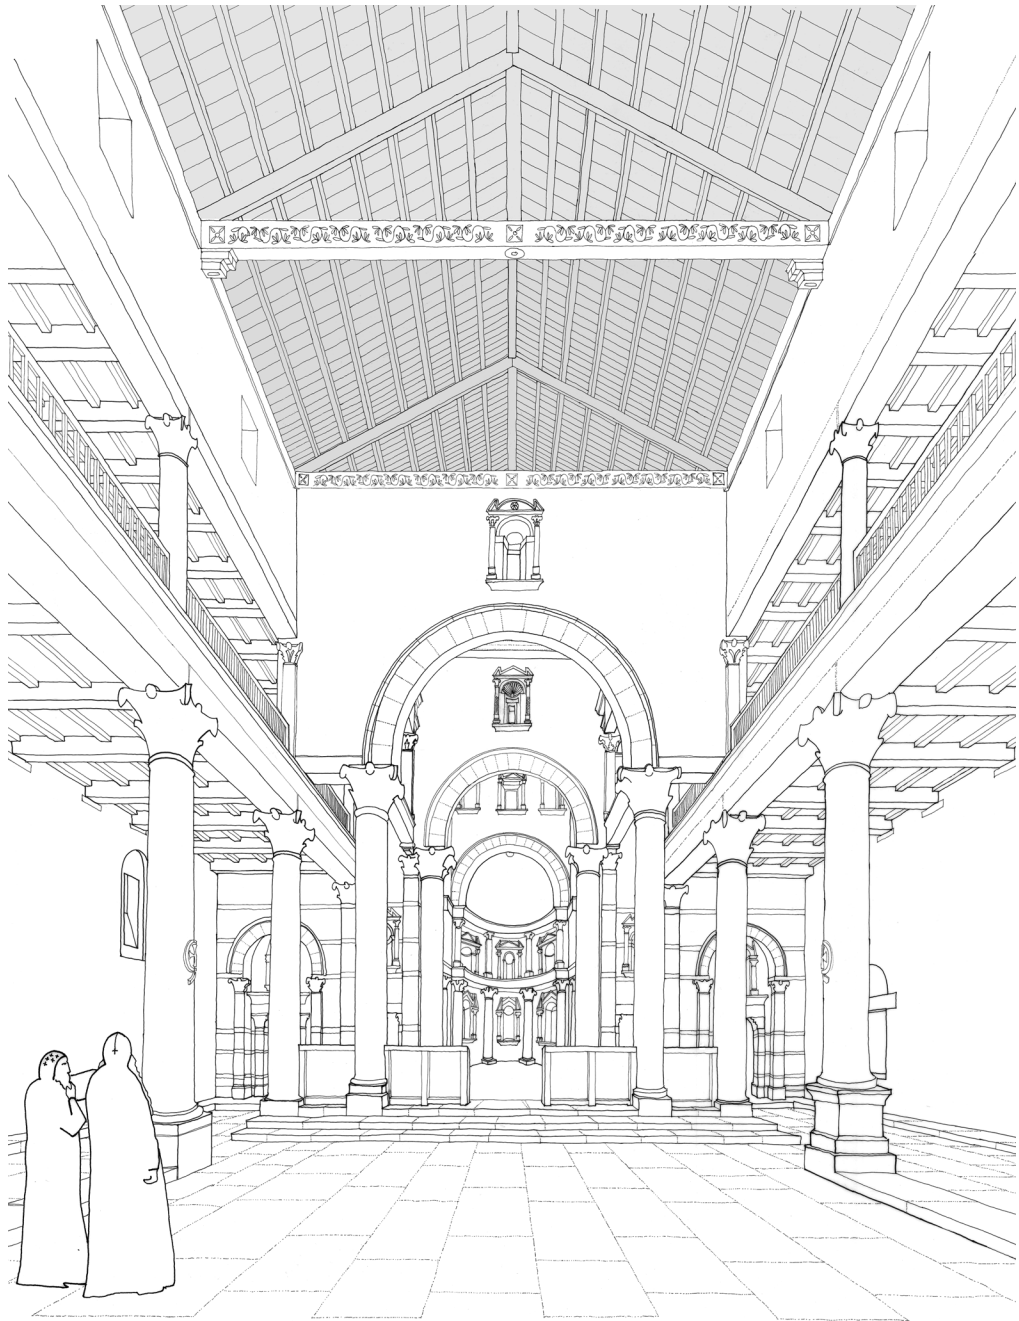
FIG. 23.  
Perspective  
reconstruction  
showing triumphal  
arch from center of  
nave, with shaded  
area representing  
possible flat soffit  
(drawing: author,  
2014)

in some way, to the articulation of the upper gallery. Assuming this had columns, pilasters would have had to have been positioned at the ends of the wall to relate to these columns (as shown in figure 23). The degree to which the plane of such a triumphal arch might have been perforated with openings is also a matter of conjecture: a single framed opening is shown in the

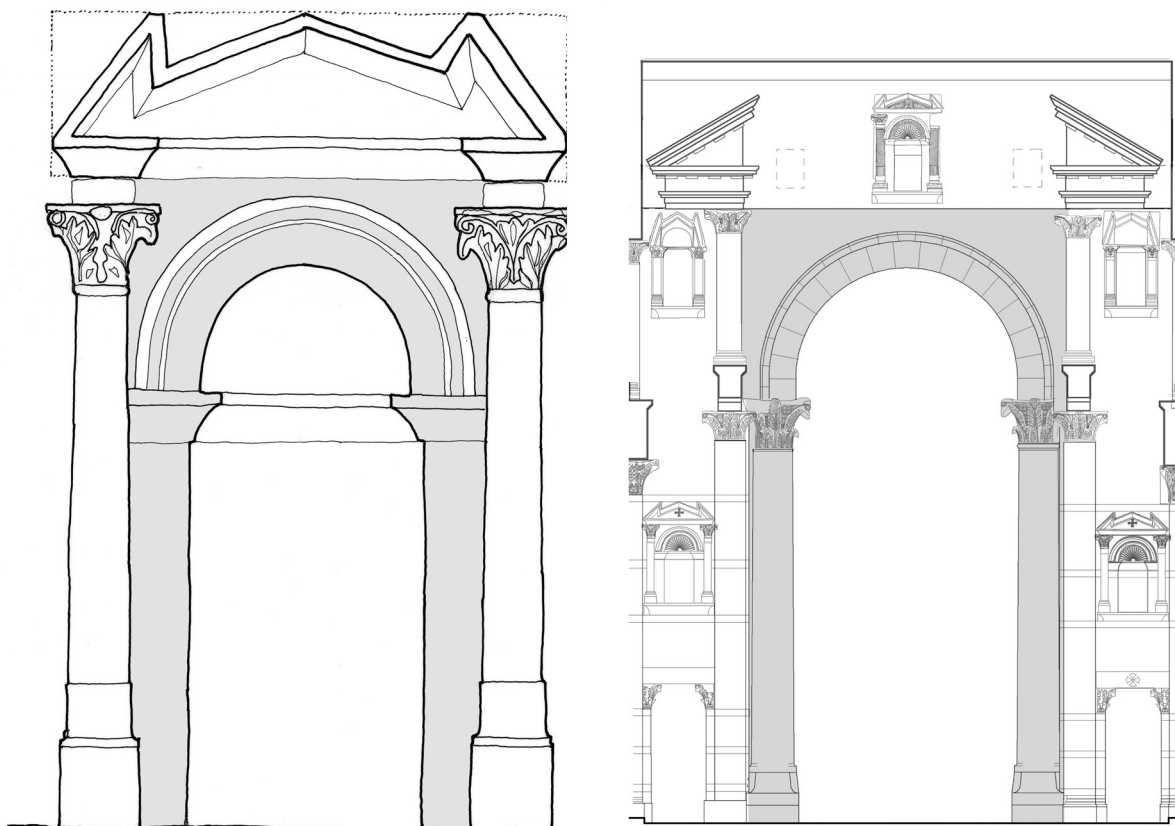
FIG. 26. A typical niche from the sanctuary (left) and the central part of the sanctuary facade with split pediment superstructure (right). Inner arches are shaded in gray tone (drawing: author, 2015)

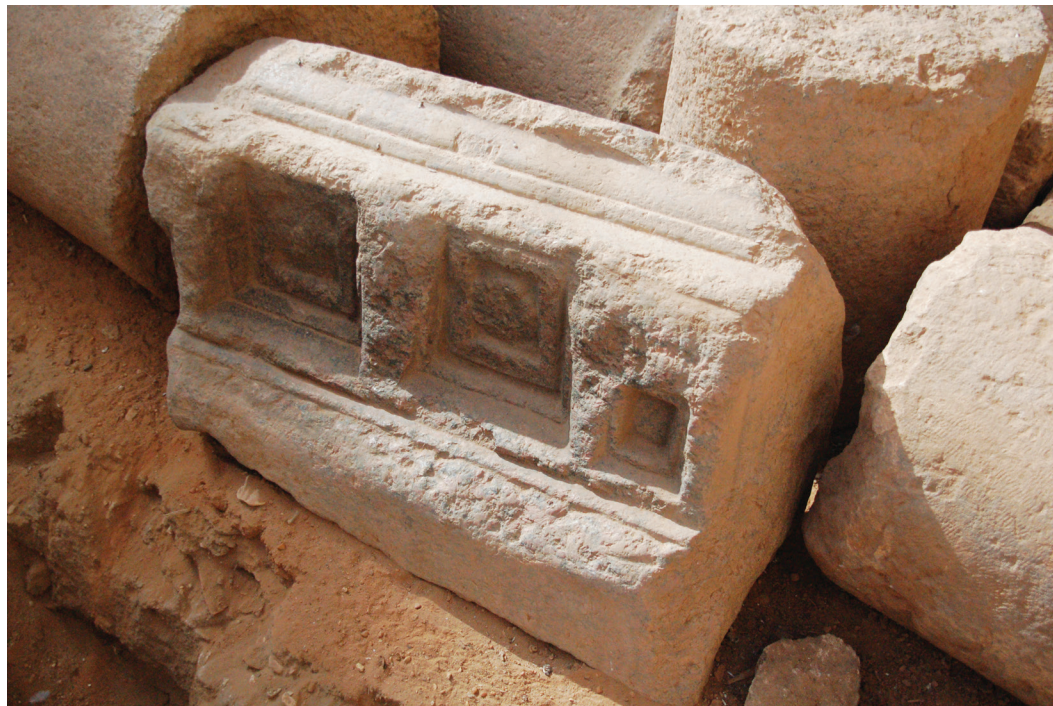
FIG. 27.  
Reworked  
granite cornice  
block with  
coffered  
modillions  
(photo: author,  
2013)

same forms appear in the Nabataean architecture of Petra and Madā'in Šālīḥ, as well as at late Roman sites such as Baalbek. An almost universal characteristic of such pediments is their articulation through elaborate cornices, especially those with modillions. One such loose cornice block, reworked from a piece of spoliated granite, still survives in the nave of the Red Monastery church today (fig. 27). The halves of the pediment could have been expressed in a great variety of ways, with different degrees of solidity and different spatial consequences. They may have been built into masonry boxes extending to the undersides of the trusses of the nave. They may have been angled in two directions, as in the style of the Palazzo delle Colonne in Cyrenaica,<sup>76</sup> or angled only in their forward plane facing the nave, in the manner of the second-century gate from Miletus. The latter alternative is shown in figures 21D and 25.

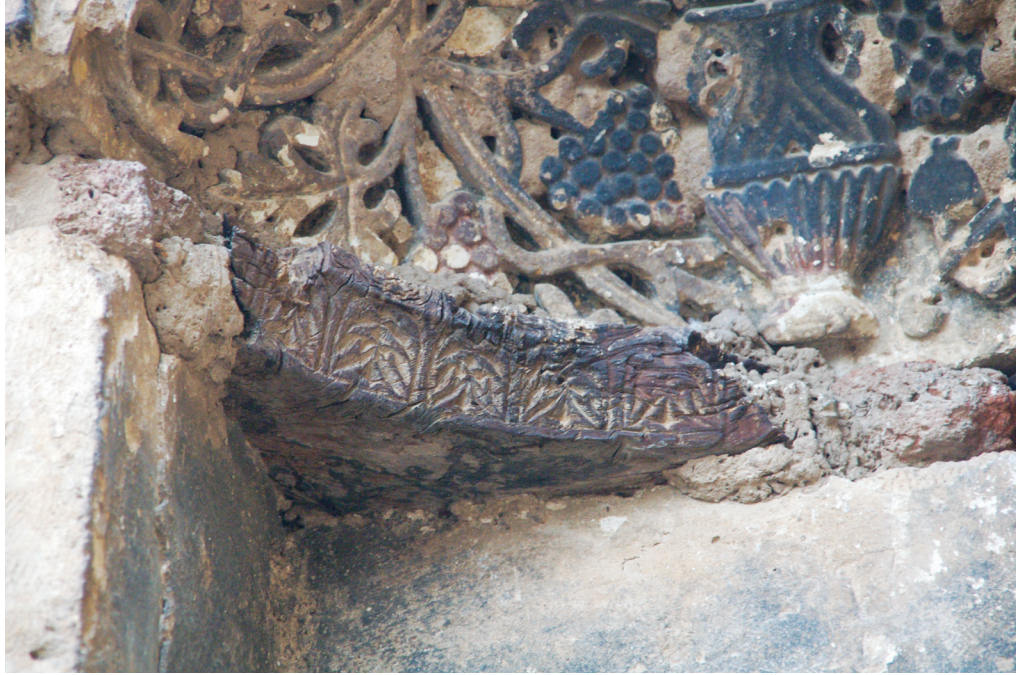
FIG. 30.  
Wooden band  
with carved  
decoration under  
a high-level niche  
in the south hall  
of the White  
Monastery (photo:  
author, 2012)

possible, for example, that the originals of the curved timber beams of the entablature above each tier of columns had carved decoration, similar to that found at a smaller scale in the White Monastery church (fig. 30).

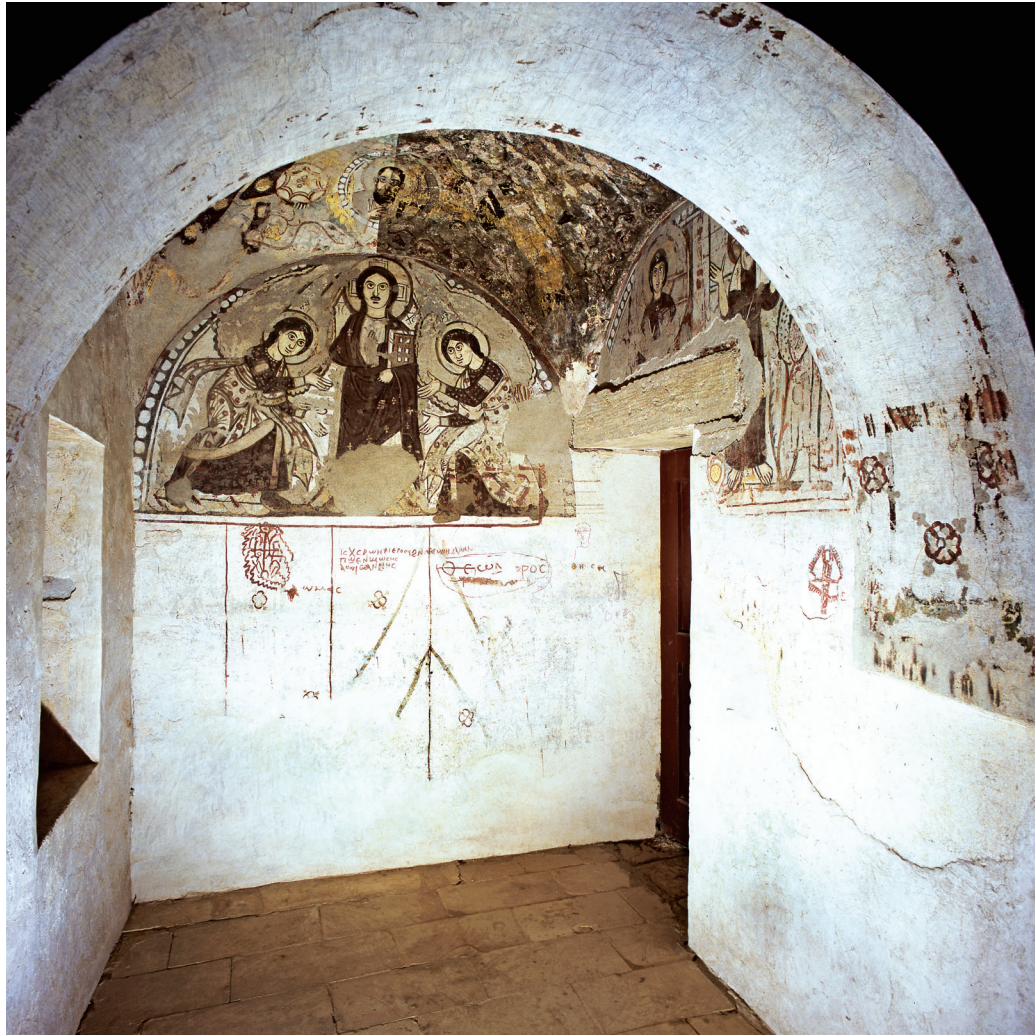
FIG. 32.  
View of the  
pendentive  
vault over the  
small north side  
chamber (photo:  
A. Vescovo,  
2012, courtesy  
of the American  
Research Center  
in Egypt)

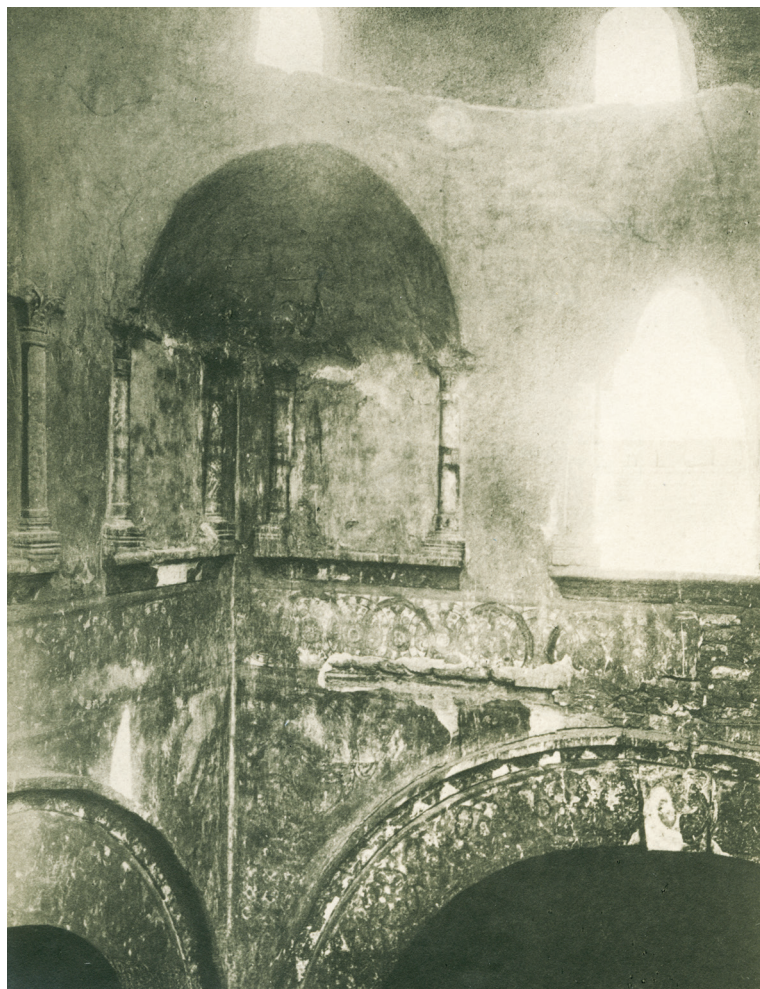
FIG. 33.  
View of an arched  
squinch from the  
clerestory of the  
Red Monastery  
church sanctuary  
prior to removal  
in 1909 (unknown  
photographer;  
Istituto Nazionale di  
Archeologia e Storia  
dell'Arte, 66818)

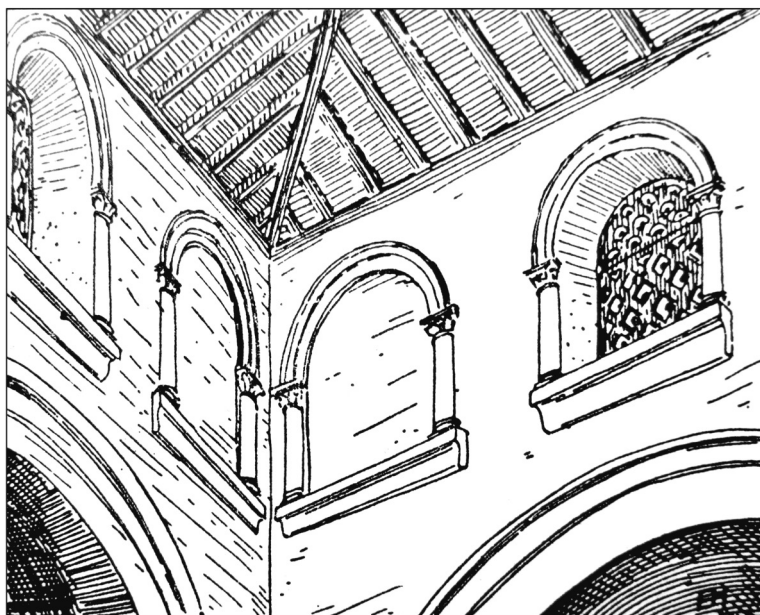
FIG. 34.  
Reconstruction by  
Samuel Guyer of the  
clerestory of the Red  
Monastery church  
sanctuary with arched  
windows and niches  
and a pyramidal  
roof (from F. Sarre  
and E. Herzfeld,  
*Archäologische Reise im  
Euphrat- und Tigris-  
gebiet, 1911–1920*  
[1920], 4: pl. 122.)

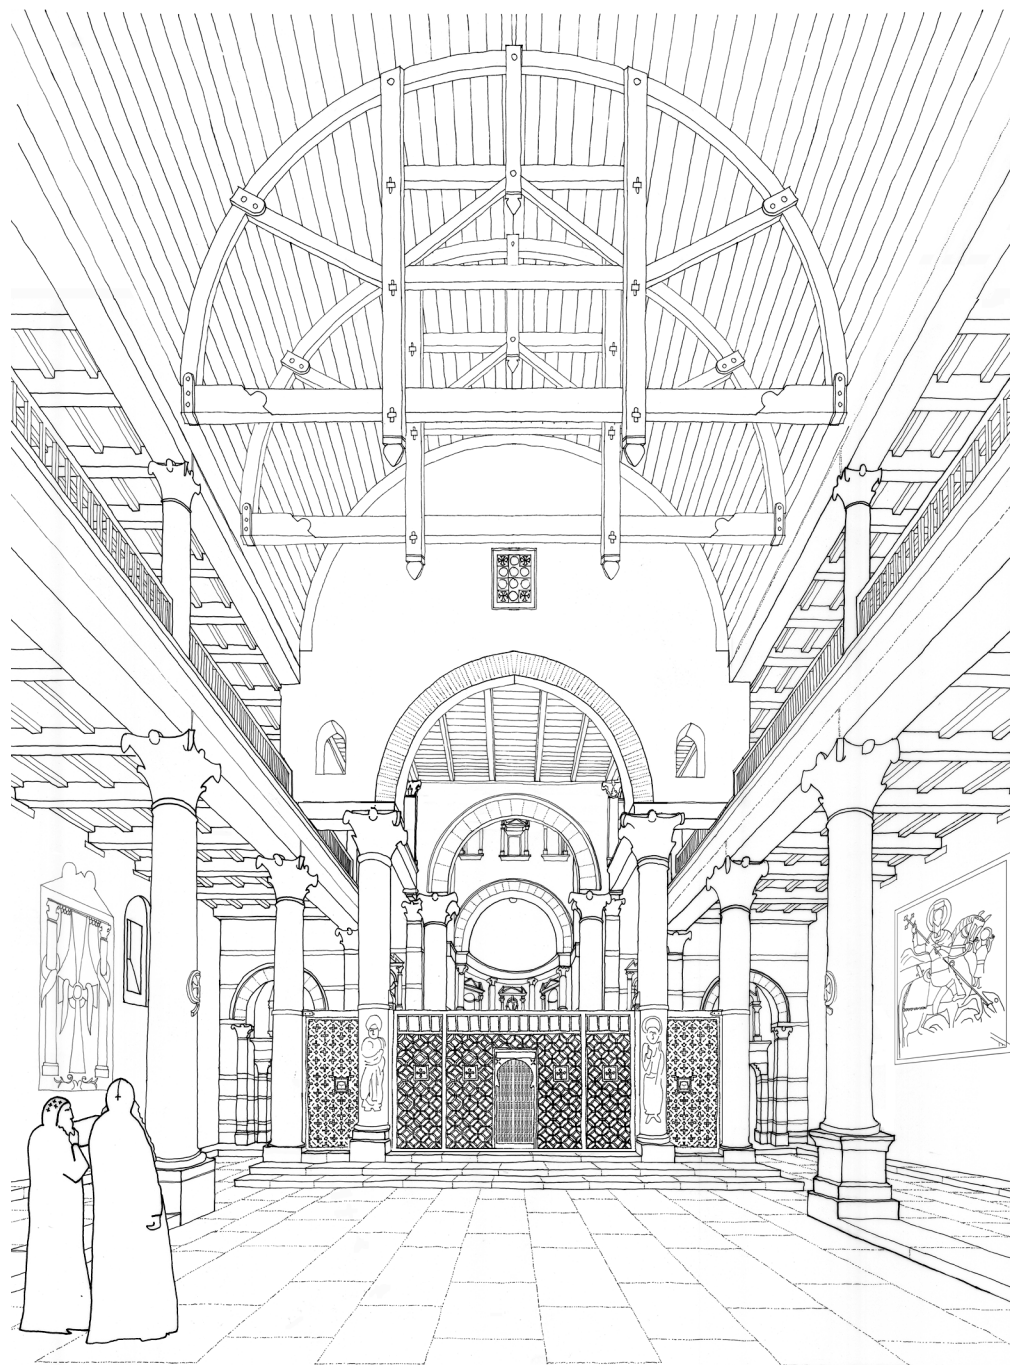
FIG. 39.  
Perspective view  
of reconstructed  
nave of Red  
Monastery church  
in the medieval  
period looking  
east, showing  
barrel vaulted roof  
without clerestory  
and pointed arch  
over columns  
on edge of bema  
(drawing: author,  
2016)
